Shredded Serpentine Belt Destroys Volvo XC60 2.4L

D5244T Engine

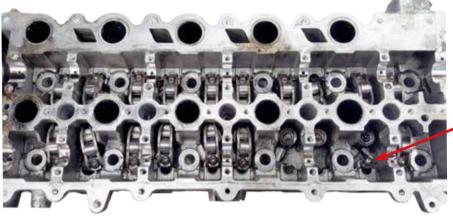
The valve lifters have been smashed out of the head due to the serpentine belt shredding, which caused the timing belt to fail.

The serpentine belt that drives all the accessories had frayed, and part of the belt managed to get between the timing cover, which in turn caused the timing belt to fail.

The cylinder head was inspected and had smashed all the valve lifter bores in the cylinder head and bent all the valves. The cylinder head was beyond repair, and another cylinder head could not be sourced, giving the customer no other option than to fit a second-hand engine.

It is a common issue for the serpentine belt to cause this type of expensive failure and it is important that the serpentine belts and tensioners are replaced at the correct intervals OR when showing signs of wear.
