Ford/Mazda 2.6L G6 Engine: Broken Valve Guides & Bent Valves

1991 – 2006 Ford Courier
1991 – 1997 Ford Raider
1990 – 2006 Mazda B2600
1997 – 2006 Mazda Bravo

An assembly error while fitting the rockers has broken off the valve guides and bent the exhaust valves.

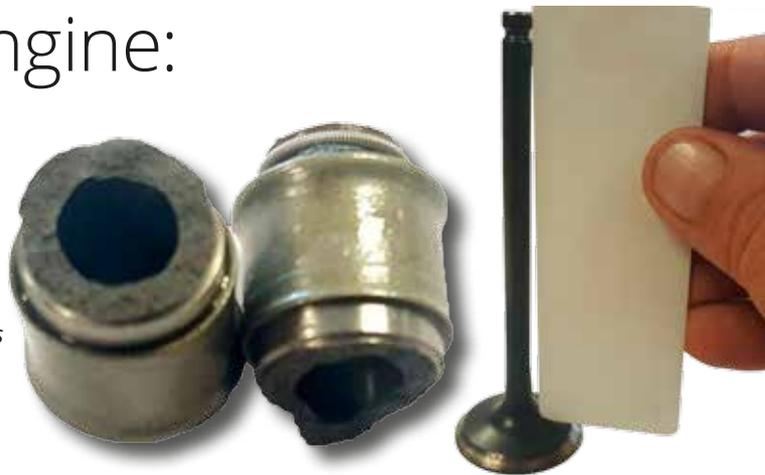
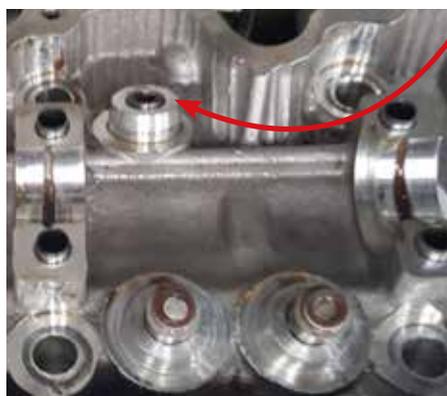
had also cracked or broken off all of the exhaust valve guides below the seal.

This type of damages is a common occurrence with these cylinder heads. It is caused by the rocker arms not being aligned with the tip of the valves when tightening the rockers down. This causes the lifters at the end of the rockers to slide off the tip of the valve and push sideways on the valve stem which in turn bends the valves and cracks the valve guides.

The cylinder head was removed and sent in for inspection. Upon dismantling the head, it was found to have four bent exhaust valves, and it

All Head Services replaced all the exhaust valves and guides and assembled the cylinder head along

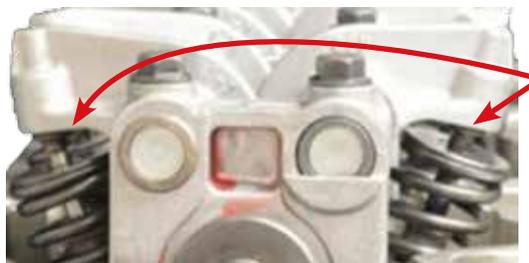
When assembling the rocker shaft make sure that the lifters or tappet adjusters are sitting correctly on the valves before you tighten the bolts. If the adjusters are caught on the valves you will break something expensive.
