Holden 1.8L Z18XER & F18D4 VVT Rattles

2007 - 2010 Holden Astra AH 1.8L Z18XER
 2009 - 2016 Holden Cruze JG / JH 1.8L F18D4

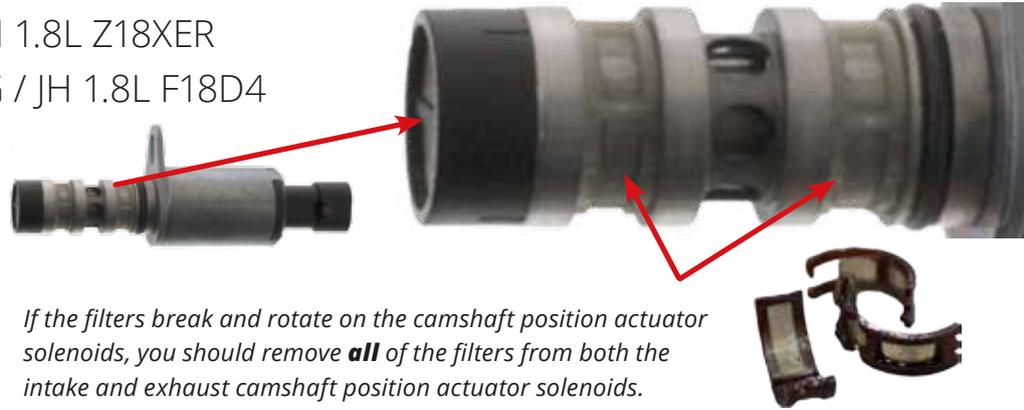
The next thing to check is the filters on both the intake and exhaust camshaft position actuator solenoids (mounted on the sides of the head behind the timing belt). Remove the solenoids and check if the filters are broken. If so, this will allow the filters to rotate which

reduces the oil flow, and causes the same symptoms.

If the filters break and rotate on the camshaft position actuator solenoids, you should remove **all** of the filters from both the intake and exhaust camshaft position actuator solenoids.

Holden has released a service fix which instructs technicians to remove **all** of the filters and refit the solenoids without filters. Their engineers have decided that the filters are only required when the engine is being run in, so it is OK to remove them. This should restore normal operation of the VVT system and the codes can be cleared and not return. If not, check for electrical faults and oil pressure issues. If both are OK, then replace the phasers.

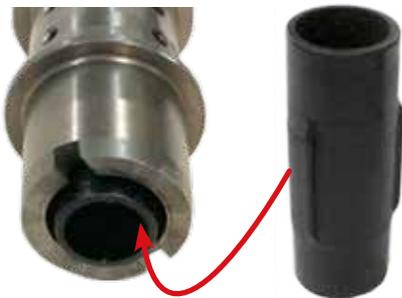
The usual cause of the rattles is when a new head or camshafts are fitted, and the plastic oil flow tubes are left out. The tubes are crucial for the correct flow of oil. Without the tubes in place, oil is not being fed to the VVT phasers which in turn causes the phasers to rattle, lack of power and DTC's recorded. The tubes **MUST** be fitted into the ends for the camshaft before the phasers and bolts are mounted.

Oil flow tubes **MUST** be fitted into the end of the camshaft.

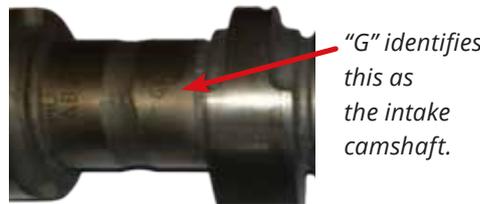
The camshafts can also be fitted incorrectly, so they have been marked. The intake cam has a "G" beside the second last lobe. The exhaust cam has a "D" in the same place. An "I" and "E" would have made more sense, but who am I to judge. ✓

"G" identifies this as the intake camshaft.

"D" identifies this as the exhaust camshaft.
