Holden Alloytec V6: Oil Pickup Blockage

One of All Head Services customers has posted on this story of a VZ Commodore Crewman with an Alloytec V6 engine that failed to start one morning.

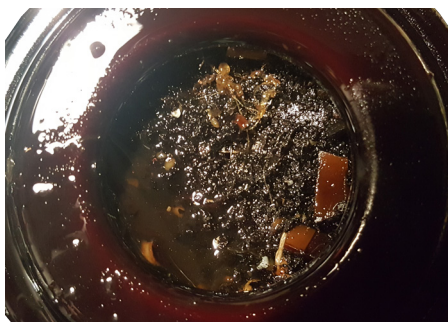
Due to the amount of oil sludge build up in the cylinder heads and timing cover it was decided to remove the sump and inspect it and the pickup for potential blockage. When the pickup was checked it was found to be nearly completely blocked as you can see in the picture below. If the pickup had not been inspected another catastrophic engine failure would have been soon.

The picture on the left is the oil pickup as it was removed from the engine which is nearly completely blocked as compared to a new one on the right.

Like other modern engines, the Alloytec V6 is well known for its ability to turn oil into sludge, which contributes to the wear in the timing chains, for which it is also infamous. The recommended interval for oil changes is 15,000km, which might be ambitious now that these engines are getting older. They also do not have a conventional oil pressure warning light. They have an oil pressure sensor connected to the ECM which sends a message to the instrument cluster and logs a fault code if the oil pressure is low. This vehicle showed no messages and had not logged a code.

In this case the oil pickup and sump were cleaned and refitted. A new timing chain kit, and reconditioned cylinder heads were fitted and the vehicle is now running as good as new. It might pay to encourage your customers to get the oil changed earlier and if you have to do any major engine repairs, check the oil pickup.

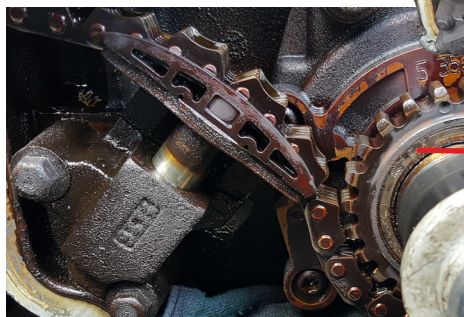
After checking the basics such as fault codes (there were none), ignition and fuel (both OK). A compression test showed that it had no compression. The rocker covers and the timing cover was removed and to check the valve timing. The timing chain guides and chains were worn out, and it was found that the cam timing had jumped six teeth on the primary chain. The primary chain guide and tensioner pad were both worn down to the metal, and the chain tensioner was fully extended. Not an uncommon occurrence for this type of engine and it was safely assumed that this was the cause of the no start situation.

The primary timing chain has worn out completely, but this is not the only problem.

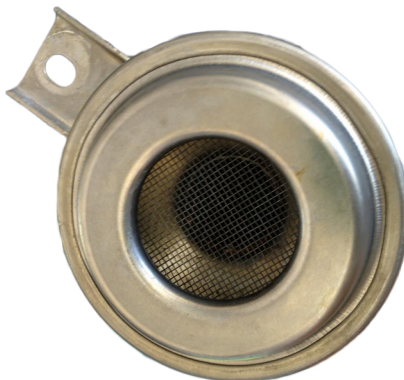
It is possible to remove the sump in these vehicles without removing the engine or the K Frame.

1. Remove the two bolts securing power steering lines to K Frame cross brace.
2. Remove the one bolt securing the auto transmission cooler pipes to RHF of K frame.
3. Remove both of the engine mount nuts from under the vehicle.
4. Remove the two sway bar mounting bolts and move power steering rack backwards.
5. Jack up the engine under bell housing (use a wooden block) slowly until it touches firewall.
6. Remove the sump bolts and remove the sump and pick up sliding it between the block and the K Frame.

This saves a lot of time and no exhaust pipes, fuel lines, radiator hoses etc. need to be removed to do this!
