Excessive Sealant Seizes Camshaft: 3.2L Duratorq

We would like to thank Geoff, from All Head Services, for sharing this practical information and photos www.allhead.com.au

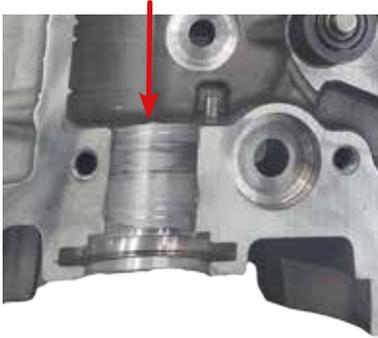
Front camshaft bearing surface in the head showing the signs of imminent seizure from lack of oil.

The valve cover and camshaft cradle were removed they noticed that the camshaft had begun to grab on the front camshaft journals.

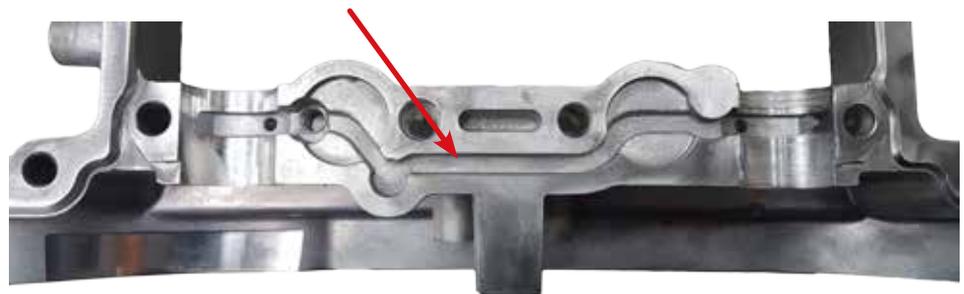
This is the oil supply gallery to the camshafts in the camshaft cradle that was partly blocked from unnecessary and excessive sealant application.

The cylinder head was removed and sent in for inspection, and during the dismantling, it was found that the front cap oil supply gallery had been partially blocked due to excessive use of sealant on the front cam cap.

The excess sealant blocked an oil gallery, in this case. However, there have been reports of sealant blocking coolant passages or ending up in the sump to block the oil pump pickups.

NO sealant is required in this area.

The workshop manual indicates that sealant is only required to be applied in a bead of 2.5mm in diameter around the outer edge of the cylinder head and the camshaft cradle. None is needed in-between the front cam bearings according to the manual. The 2.2L Duratorq engines have the same requirements.
