How **NOT** to Adjust 2RZ Valve Clearances

All Head Services had a 2RZ cylinder head from a Toyota RZH103 HiAce sent in with an issue of the valve clearances closing up and the customer having to adjust valve clearances at very short intervals due to a misfire and loss of compression.

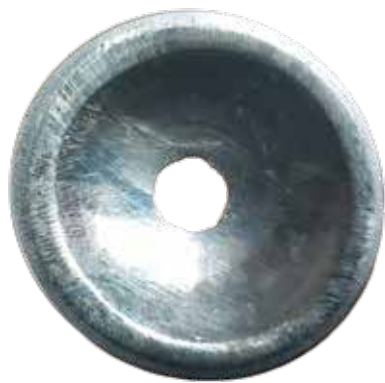
This shim's case hardening has been machined off which allowed the cam to wear a hole in it.

Many engine components are case hardened which means that they have a very hard outer layer, but are relatively soft on the inside. Once this outer layer has been worn through, the components will degrade rapidly. In this case the machining process has broken through the case hardening and has caused the shim to wear through, damaging the buckets and has worn the lobes off the camshaft.

*This is what a bucket should look like. Shims and buckets should **NEVER** be machined.*

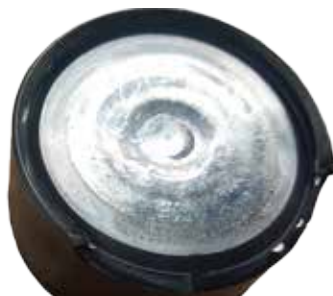
The shim was so thin, the cam broke the lip off the bucket.

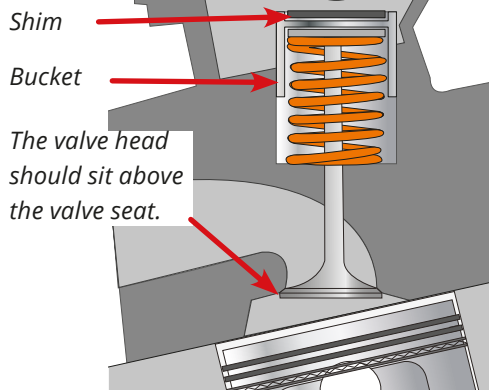
Correct Valve Clearance

Valve Clearances (Cold):
Intake 0.20 - 0.30mm
Exhaust 0.25 - 0.35mm

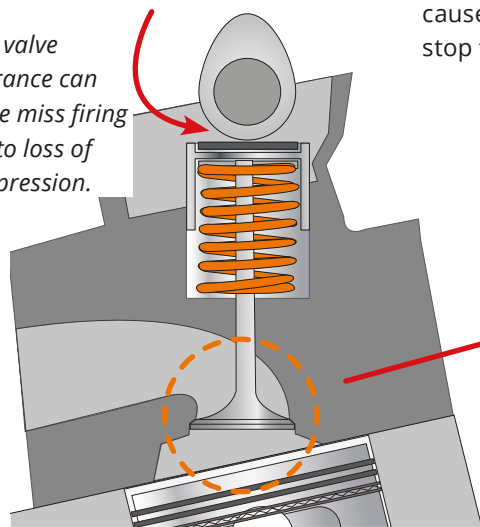
Zero Valve Clearance

Zero valve clearance can cause miss firing due to loss of compression.

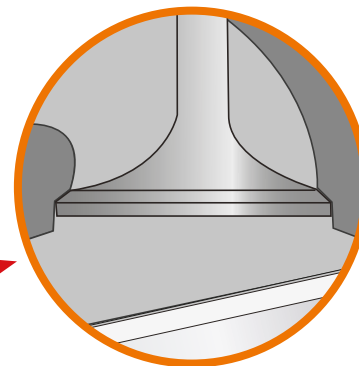
This engine had been converted to run on LPG which commonly causes the

valves to recess into the head, which closes up the valve clearance. To correct the continual closing of the valve clearances, the owner had the shims machined down. Then, the next time they machined the inside of the buckets to gain some extra clearance.

The valve has recessed into the head causing the valve clearance to close up.

If the valve clearances on any engine continually close up there is usually an underlying issue and a vehicle being run with an out of tune LPG system can be a significant contributor. The cause of this must be investigated to stop further damage. 🚩
