# Holden Alloytec V6 Timing Chain Tensioner Gaskets: NO Oil Pressure

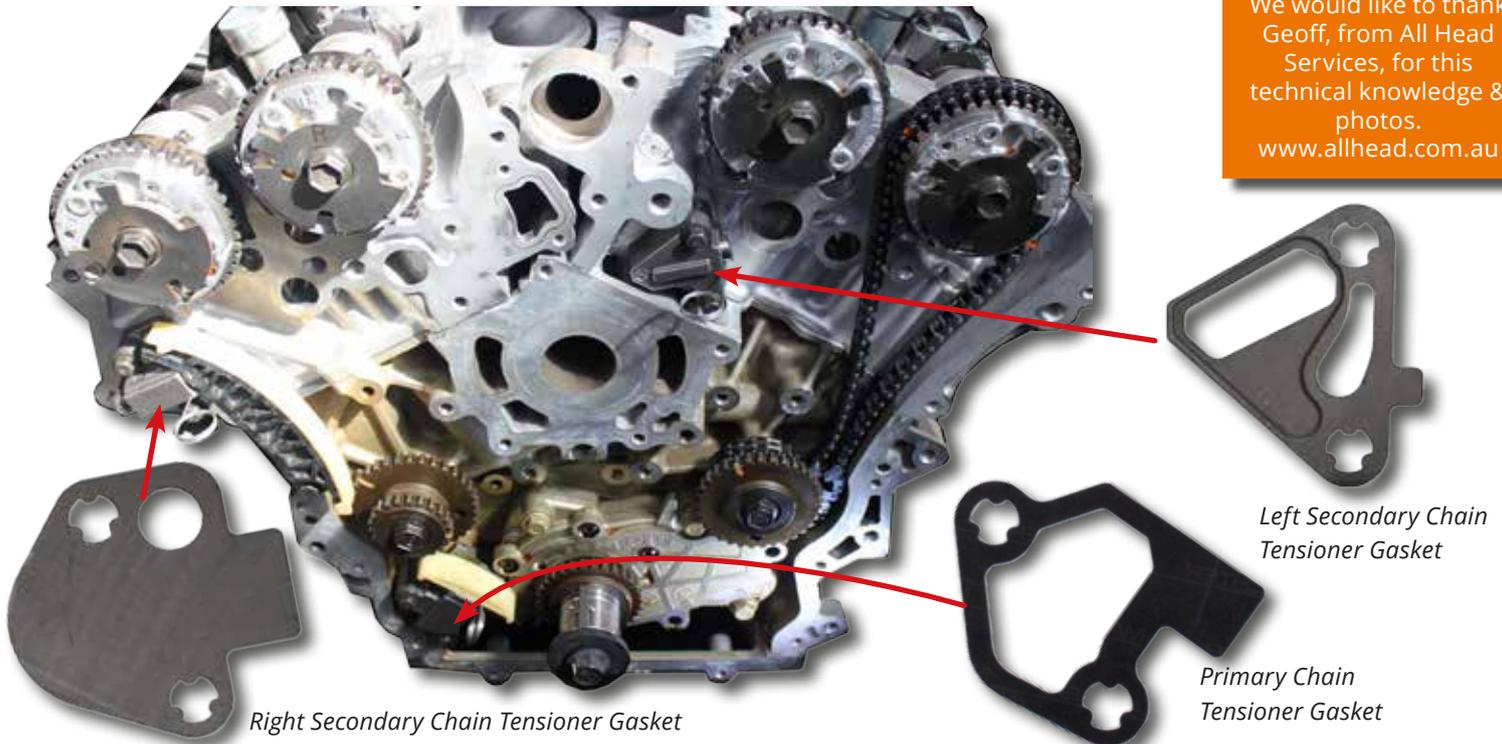
A master oil pressure gauge was fitted, and the engine was showing ZERO oil pressure at idle (should be 69 kPa / 10 psi) and 40 psi when revved to 2000 RPM. The oil pick up was checked with a camera and was clean (the pickups tend to block if the oil becomes sludgy, see Jan / Feb 2018 Tech Talk page 4468) so the timing cover was removed and the components inspected.

All of the tensioners have a small oil reservoir between their body and their mating surface, this allows for quiet and fast operation on start-up. This reservoir of oil is contained by the rubber covered metal gasket that seals the tensioners to the block or heads. As this engine was dismantled and the timing chain tensioners removed, it was found that one of the tensioners had not had the metal gasket fitted when it was being assembled. This was where the oil pressure was escaping. A new set of gaskets was fitted to

the tensioners and the engine was reassembled. The engine had full oil pressure at idle and through the rev range.

As this case shows, one small component can reduce the oil pressure in the entire engine. The lesson from this is to make sure to replace all gaskets on reassembly, and not to assume that because a component is inside the engine that it does not need a gasket or to seal correctly.
