## Detonation Damage: Tune Your LPG System!

**AHS recently had contact from a customer who had purchased a Nissan Patrol TB42 cylinder head, and after fitting had a complaint of oil in the cooling system. The cylinder head had been on the vehicle for seven months and had only travelled 2000 km. The vehicle was dual fuel with petrol and LPG. The cylinder head was removed and sent back to AHS, along with the head gasket.**

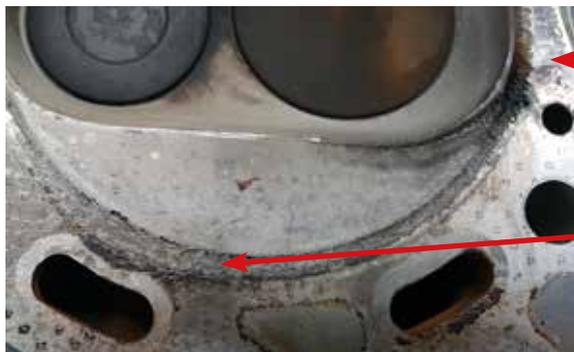
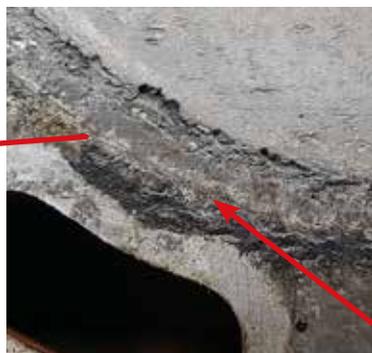
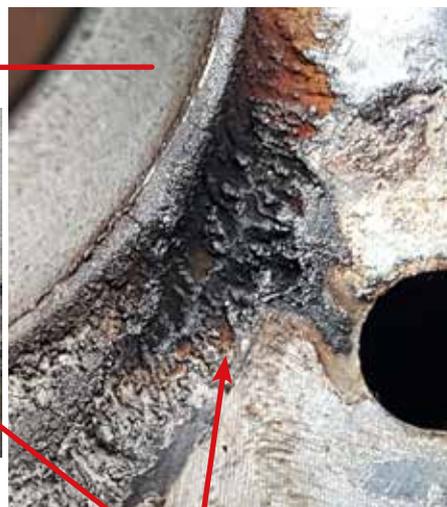
Upon inspection, the head was found to be bent .010", with the obvious cause being severe detonation (which is uncontrolled combustion). This had melted the cylinder head around the combustion chamber fire ring area, leading to the head gasket failure, which is how the oil got into the coolant.

LPG provides a hotter environment in the combustion chamber, which in turn increases the temperature of the cylinder head and if you add detonation into the mix, the head can melt. In this case, the out of tune LPG system was found to be the cause of the detonation issues and the damage to the engine.

*Detonation has melted the fire ring of the cylinder head.*

It is imperative with any fuel system and critical with LPG that the engine is kept in tune. Detonation can be caused by many things, but incorrect ignition timing, ignition advance curve and air/fuel ratio are some of the main culprits. Dual fuel applications add an extra complication due to the different characteristics of petrol and LPG.

At low rpm, the LPG burn rate is slower, so more ignition advance is needed, at high rpm the LPG burn rate is faster, so less advance is required.

Both of these are the opposite of the requirements of petrol, which can then increase the chance of detonation if the advance curve is not recalibrated. Also if the air/fuel ratio is too lean, this will increase the speed and temperature of combustion, which again raises the chance of detonation.

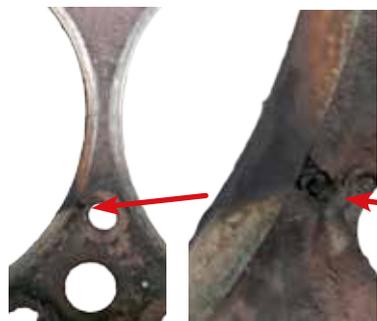
*The excess heat and pressure in the combustion chamber from detonation has caused the head gasket to fail.*
