Nissan ZD30: MAF Sensor Causes Piston Seizure

AHS recently rebuilt a Nissan ZD30 3.0L, Non-Common Rail Diesel long motor out of a 2007 Nissan Patrol. Nothing out of the ordinary, however, an often overlooked part meant that this engine had a very short lifespan.

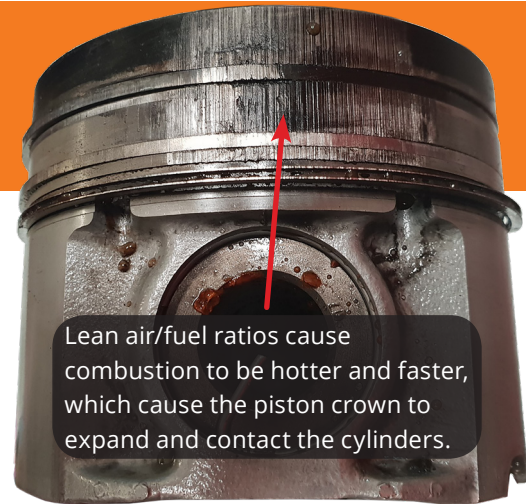
It was found that the pistons had grabbed on the ring land area (see picture above), and the bores were blue and cracked through the centre of the bores. The injector pump and injectors were tested independently and were both within specifications. The customer had the radiator and cooling system checked and the water pump and thermostat had been replaced when the reconditioned engine was fitted. All good so far.

As these sensors age, some contaminants get burnt onto the hot wire and insulate it. This gives the ECU the impression that there is less air entering the engine than the actual volume. So running at full turbo boost, with not enough fuel delivery causes excessive combustion chamber and piston temperatures, which caused the ring lands to grab on the cylinders. The airflow meter in the ZD30 can also be attributed to the cracked pistons that these engines suffer from.

Lean air/fuel ratios cause combustion to be hotter and faster, which cause the piston crown to expand and contact the cylinders.

Contaminated MAF sensors often do not log fault codes, even though they are not sending an accurate signal. It is common in the trade to clean MAF sensors, however, cleaning rarely brings the sensor back to 100% accuracy. It is recommended that a new sensor be fitted.

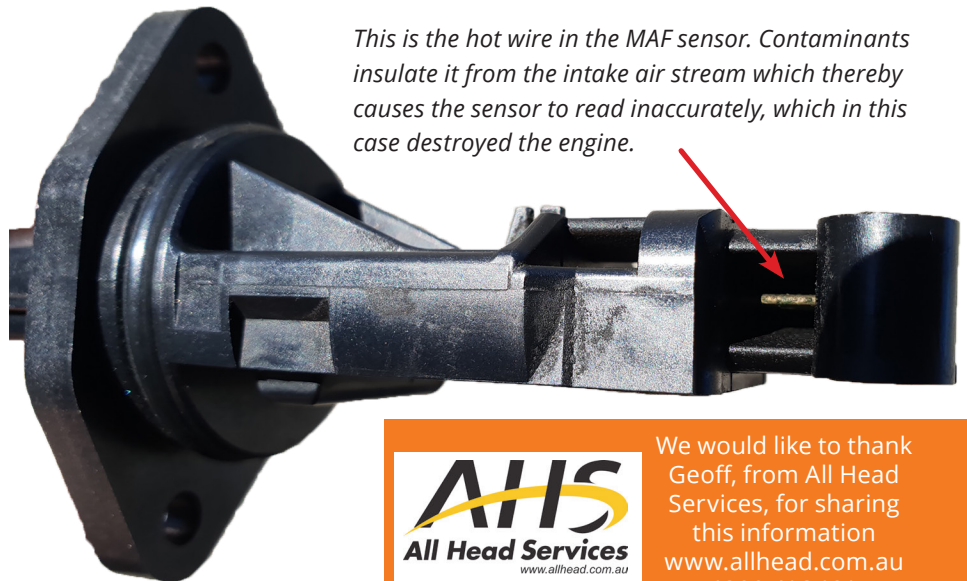
AHS then had the Mass Air Flow (MAF) sensor removed from the vehicle and sent away for independent testing. The test report showed that the MAF sensor failed on all but 2 steps of the 10-step test, with only the idle and just above idle tests passing. The analysis showed that the higher the airflow, the leaner the engine got. This explains why the vehicle ran fine on relatively flat going and part throttle and failed under load

This is the hot wire in the MAF sensor. Contaminants insulate it from the intake air stream which thereby causes the sensor to read inaccurately, which in this case destroyed the engine.
