No.1 Cause of Modern MLS Head Gasket Failure: Poor Surface Preparation

We would like to thank Geoff, from All Head Services, for this technical knowledge. www.allhead.com.au

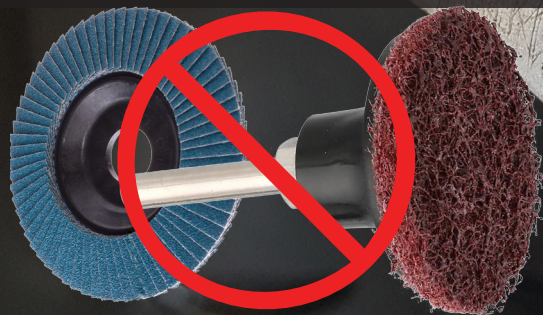
You can see the damage caused to the sealing surface of this cylinder block by a "Whizzy Disc" which has made the surface too rough. This would cause an MLS head gasket to fail.

MLS gaskets cannot conform to surface irregularities outside of their specifications, usually 20-30 Ra or less. RA stands for "Roughness Average" which is the average measurement of peak-to-valley roughness height of a "flat" surface. The lower the Ra number, the smoother the surface. Air powered whizzy discs tend to severely damage the gasket surface, by increasing the RA number, especially on aluminium cylinder blocks. This will inevitably lead to head gasket leakage and engine failure.

For the average workshop it is recommended to clean the block surface with a spray on gasket cleaner, then a plastic razor blade, then sharp steel razor blade held at 90 degrees to the block which should remove all of the old gasket material. Then sand the surface with ultra-fine wet and dry paper on a flat sanding block to produce a polished finish.

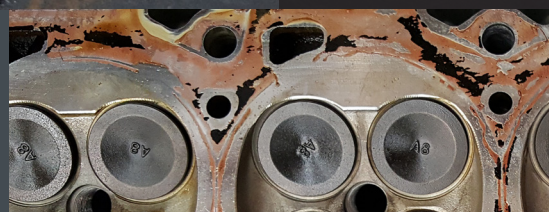
This head was sent back due to the head gasket leaking. As you can see it is covered in aftermarket sealant which has caused the MLS gasket to fail. As a result, NO warranty cover.

There is also the continual use of additional sealants (e.g. Hylomer etc.) on the gasket surfaces which will cause the head gasket to leak. MLS head gaskets already have a sealant applied, and any additional sealant coatings will stop the gaskets from working as it has been designed and it will fail to seal.

I cannot stress enough the importance of the block preparation and following of the gasket manufacturer's instructions when fitting MLS head gaskets to alleviate any chance of failure down the track. If you have any question on this topic refer to the Jan/Feb 2017 issue of Tech Talk or contact your gasket supplier. 🐦

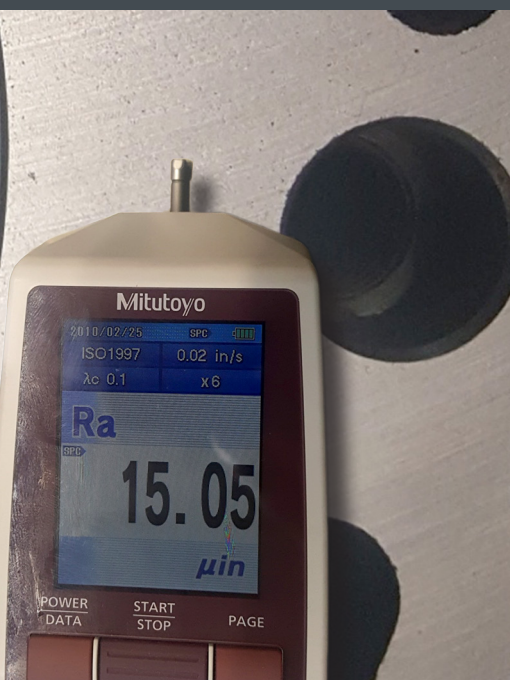
This is a block surface fresh of a surface grinder with a 15 RA surface finish as measured with a profilometer. You should aim for the closest to this as you can with sandpaper on a flat block.
