Mind the Gap: ZD30 Head Fitting Faults

2000 - 2007 Nissan Patrol GU

2001 - 2007 Nissan Navara D22

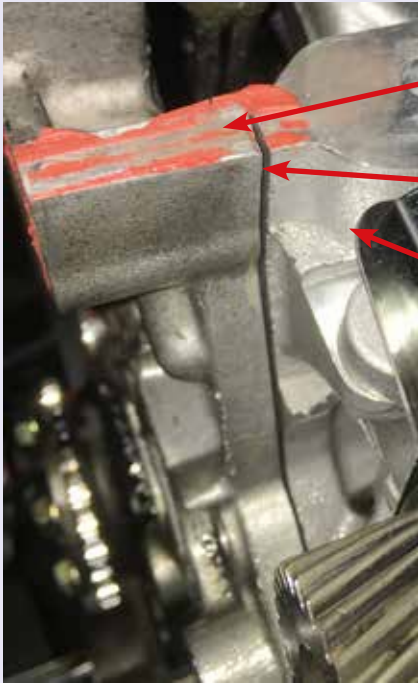
It is imperative that the correct procedure be followed when fitting these heads as failure to do so can lead to a gap between the timing gear case and cylinder head which leads to a coolant / oil leak.

See Diagram #1 and #3.

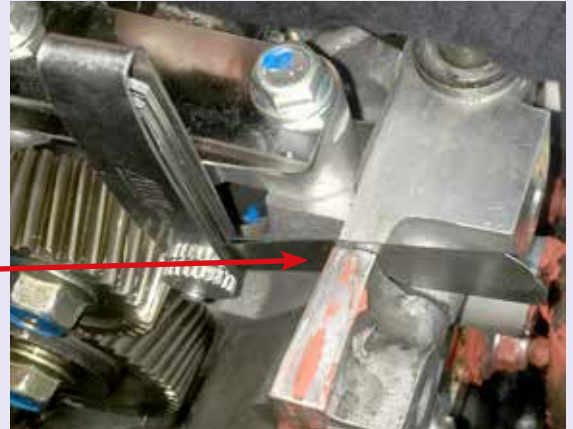
Diagram #3

Timing Gear Case

The gap you do not want

Head

There have been several instances where customers have purchased Nissan ZD30 cylinder heads and after fitting the heads there has been a coolant and oil leak at the timing gear case area near the cylinder head.

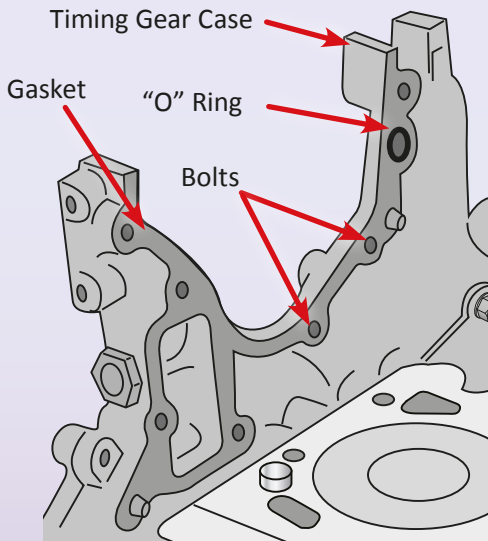
Diagram #2

CAUTION: Ensure that the "O" ring DOES NOT fall out and that the gasket is not damaged.
See Diagram #2.

5. Install cylinder head bolts and tension in sequence (See Tech Online for diagram).
1st: 40 - 49 Nm
2nd: Loosen cylinder head bolts completely.
6. Install 2 timing gear case bolts and tension to 9.8 Nm. This should close the gap.
See Diagram #2.
7. Complete tensioning cylinder head in sequence.
3rd: 98 - 102 Nm
4th: Loosen Completely
5th: 40 - 44 Nm
6th: 90 - 95°
7th: 90 - 95°
8. Tighten all timing gear case bolts to 25 - 28 Nm.
9. Check timing gear case to ensure it has pulled in flush with the cylinder head and block.
