Engine Damage After Head Repair

**Toyota HiLux/HiAce
2TR-FE 2.7L 2005 - 2016**

**Mazda BT-50/Ford Ranger
WL-C/WE-C 2.5L/3.0L
2006 - 2011**

When replacing cylinder heads, failure to refit all valve lash caps can cause costly engine damage.

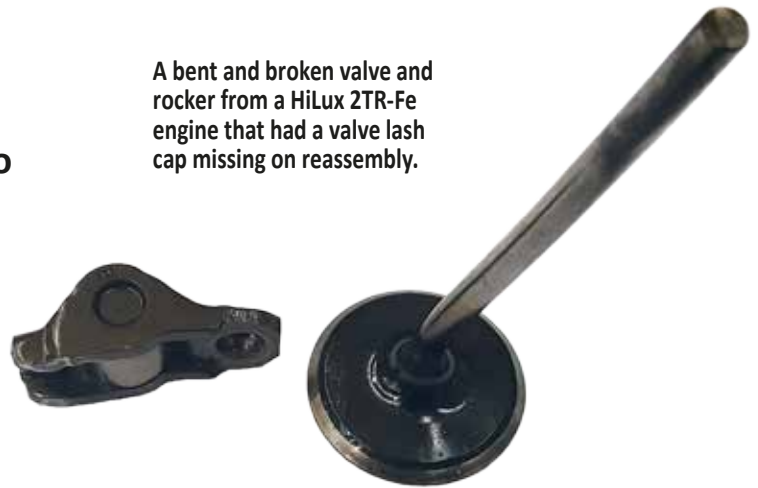
A bent and broken valve and rocker from a HiLux 2TR-Fe engine that had a valve lash cap missing on reassembly.

it was found that the lash caps from the original head had not been fitted by the customer. The valve and rocker on the affected cylinder were severely damaged. *Refer to the above picture.*

Without the lash caps fitted to the valve tips, it allows the rocker arms to slide off the centre of the valve tips. The rocker arms then push on the valve spring retainer, rather than the centre of the valve stem, which in turn allowed the valve collets to pop out. With the collets gone the valve dropped and broke after hitting the piston.

When dismantling any cylinder head, always check the end of the valve stems to see if there are any lash caps fitted. ▶

Note: Valve lash caps are used on an assortment of engines from different manufacturers, so you really need to check each cylinder head to see if these caps are fitted on every vehicle that you remove the valve gear from.

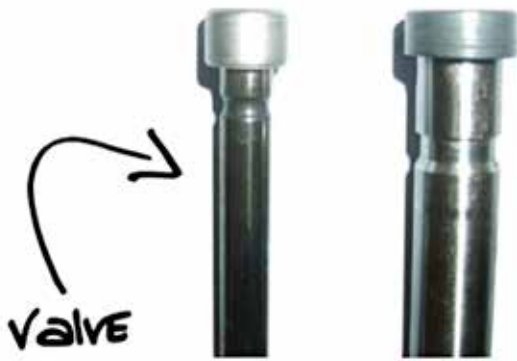
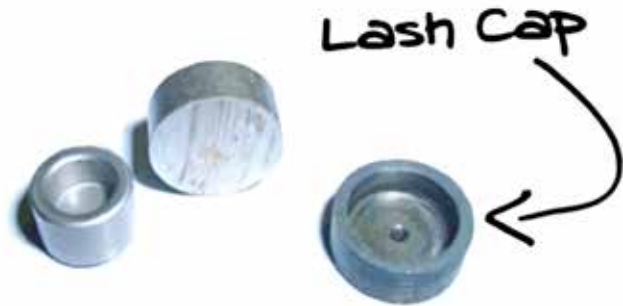
Many modern engines, in particular diesel engines have a lash cap fitted on the end of the valve that the rocker arm pushes on. *Refer to picture next page.*

The lash caps, particularly when coated with diesel engine oil, are hard to see and very easily missed when dismantling the cylinder heads.

Note: Always apply clean oil to lash caps before fitting.

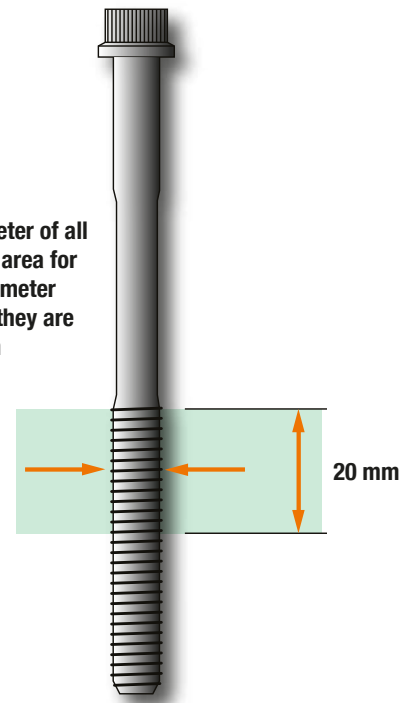
Cylinder Head Bolt Diameter - 10.40 mm Minimum *See Diagram*

Check diameter of all bolts in this area for smallest diameter and ensure they are greater than minimum

Standard Diameter	10.76 - 10.97 mm
Minimum Diameter	10.40 mm

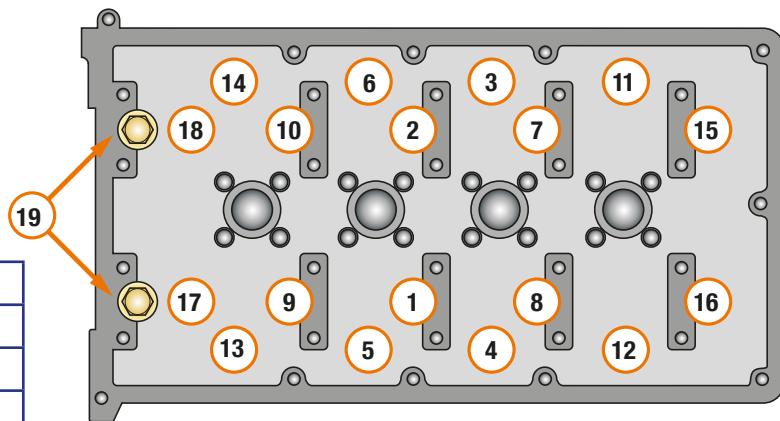
Cylinder Head Bolt Torque & Sequence

Bolts 1 to 18: 1st: 29 Nm 2nd: 29 Nm 3rd: 90° 4th: 90° 5th: 90°
Bolts 19: 19 Nm - Use sealant on bolt threads

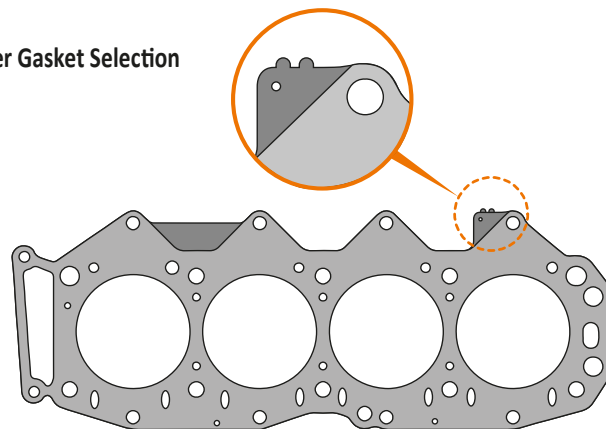
Cylinder Gasket Selection

Piston Protrusion	Gasket Selection
0.080 - 0.190 mm	One Mark (0.75 mm)
0.135 - 0.255 mm	No Mark (0.80 mm)
0.200 - 0.310 mm	Two Marks (0.85 mm)

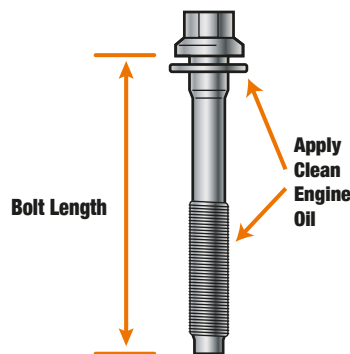
Cylinder Head Bolt Checking

*Note: See mark on head of bolt

"I" Bolt Length	
New	Wear Limit
149.0 - 150.0 mm	150.5 mm

"W" Bolt Length	
New	Wear Limit
101.2 - 101.8 mm	102.5 mm

"N" Bolt Length	
New	Wear Limit
113.2 - 113.8 mm	114.5 mm
