Camshaft Seized Causing Bent Valves After Replacing Cylinder Head.

Mazda BT50 / Ford Ranger WEC 3.0 Litre Turbo Diesel

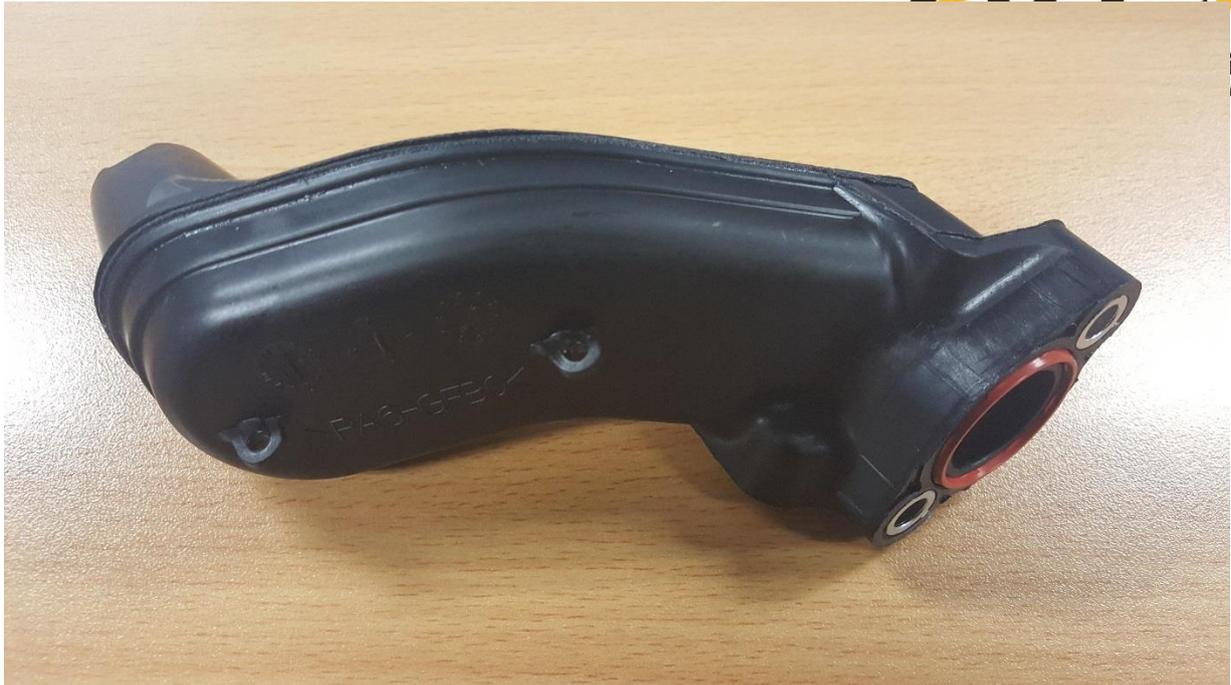
New Oil Pick Up

The customer replaced the oil pick up and rechecked oil flow to cylinder head, problem solved!

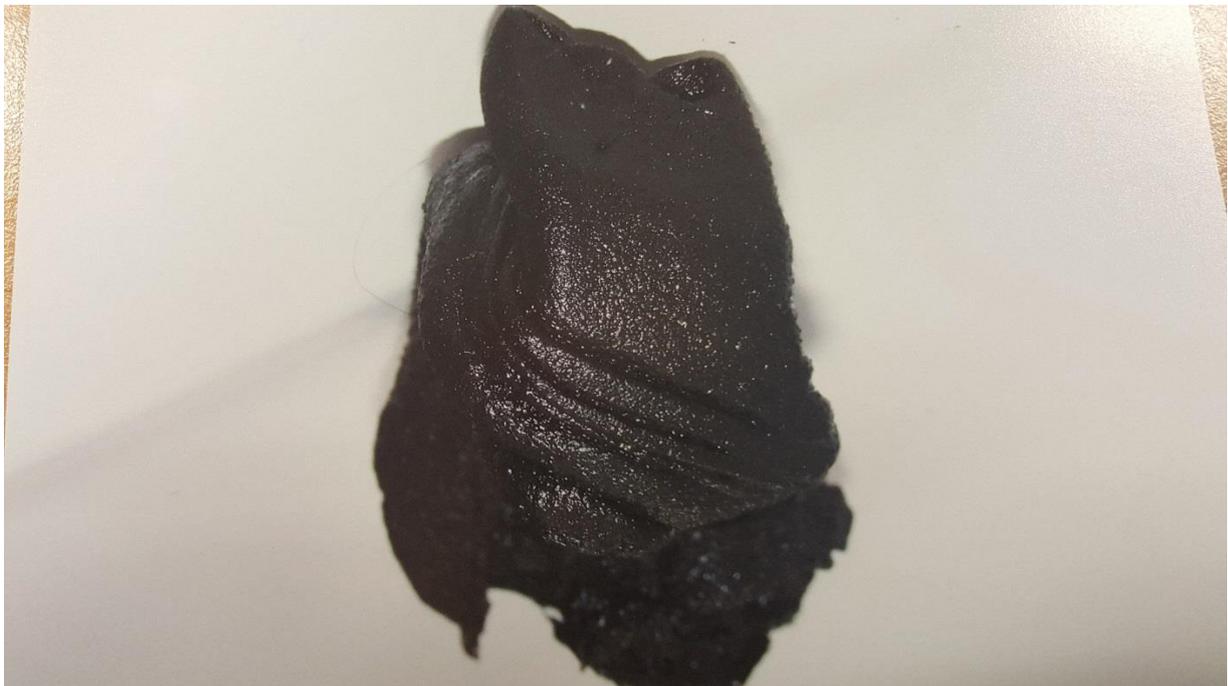
The sump was removed from the engine and upon inspection it was found that the engine oil had been extremely overheated and had melted the plastic oil pick-up in the sump.

Melted Oil Pick Up

It is imperative that when a vehicle is presented for overheating issues that the oil supply system be checked for pressure and flow.
